Debris/Ice/TPS Assessment And Photographic Analysis For Shuttle Mission STS-39

Gregory N. Katnik
NASA/Kennedy Space Center

June 1991

DEBRIS/ICE/TPS ASSESSMENT
AND
PHOTOGRAPHIC ANALYSIS
OF
SHUTTLE MISSION STS-39

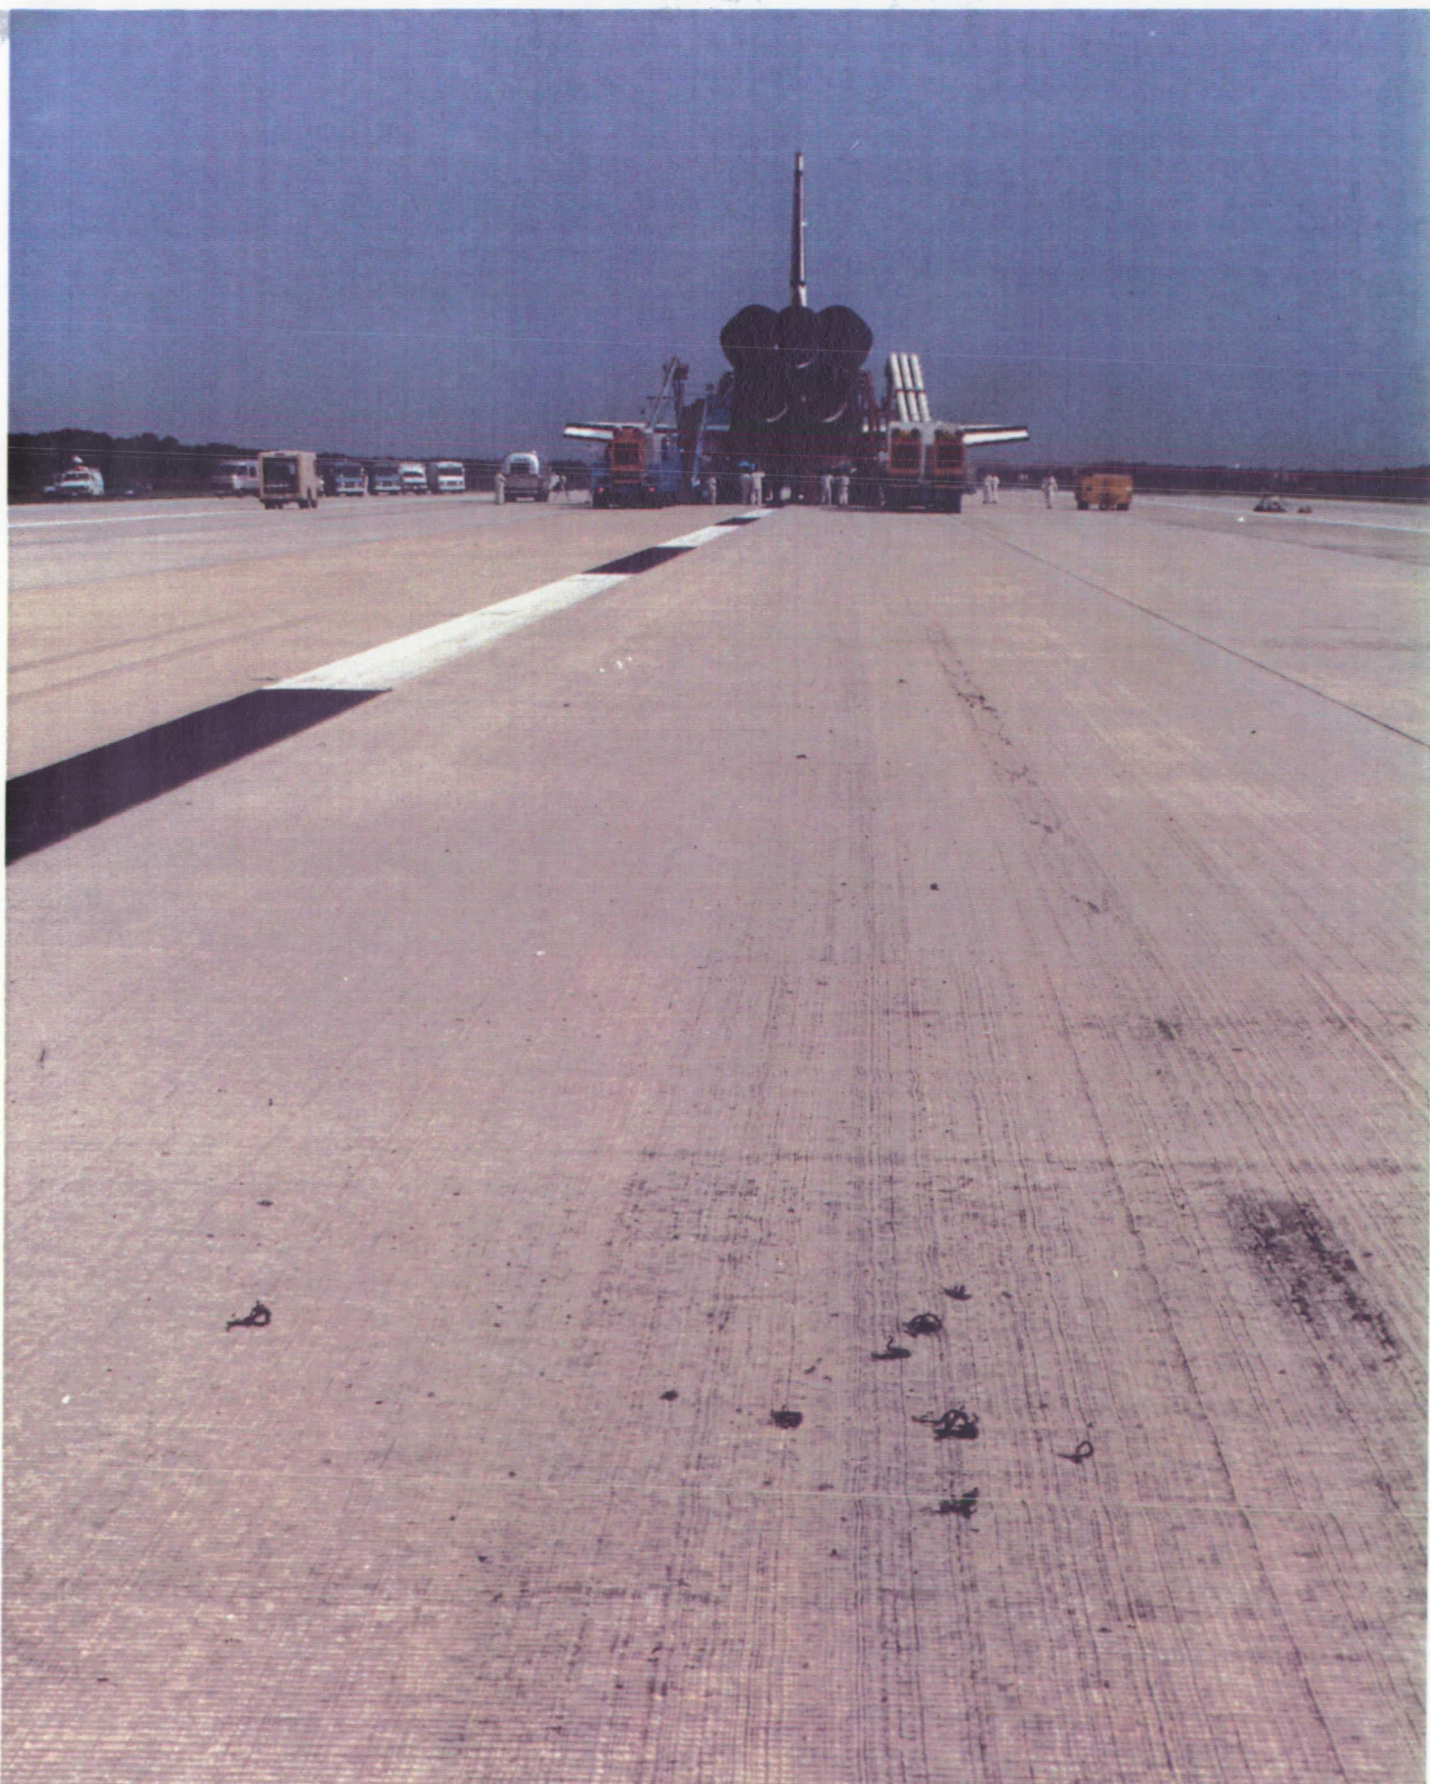
Material from the RH main landing gear tires lay on the runway within 1000 feet of the Orbiter stop point. There was no tire material at the touchdown point.

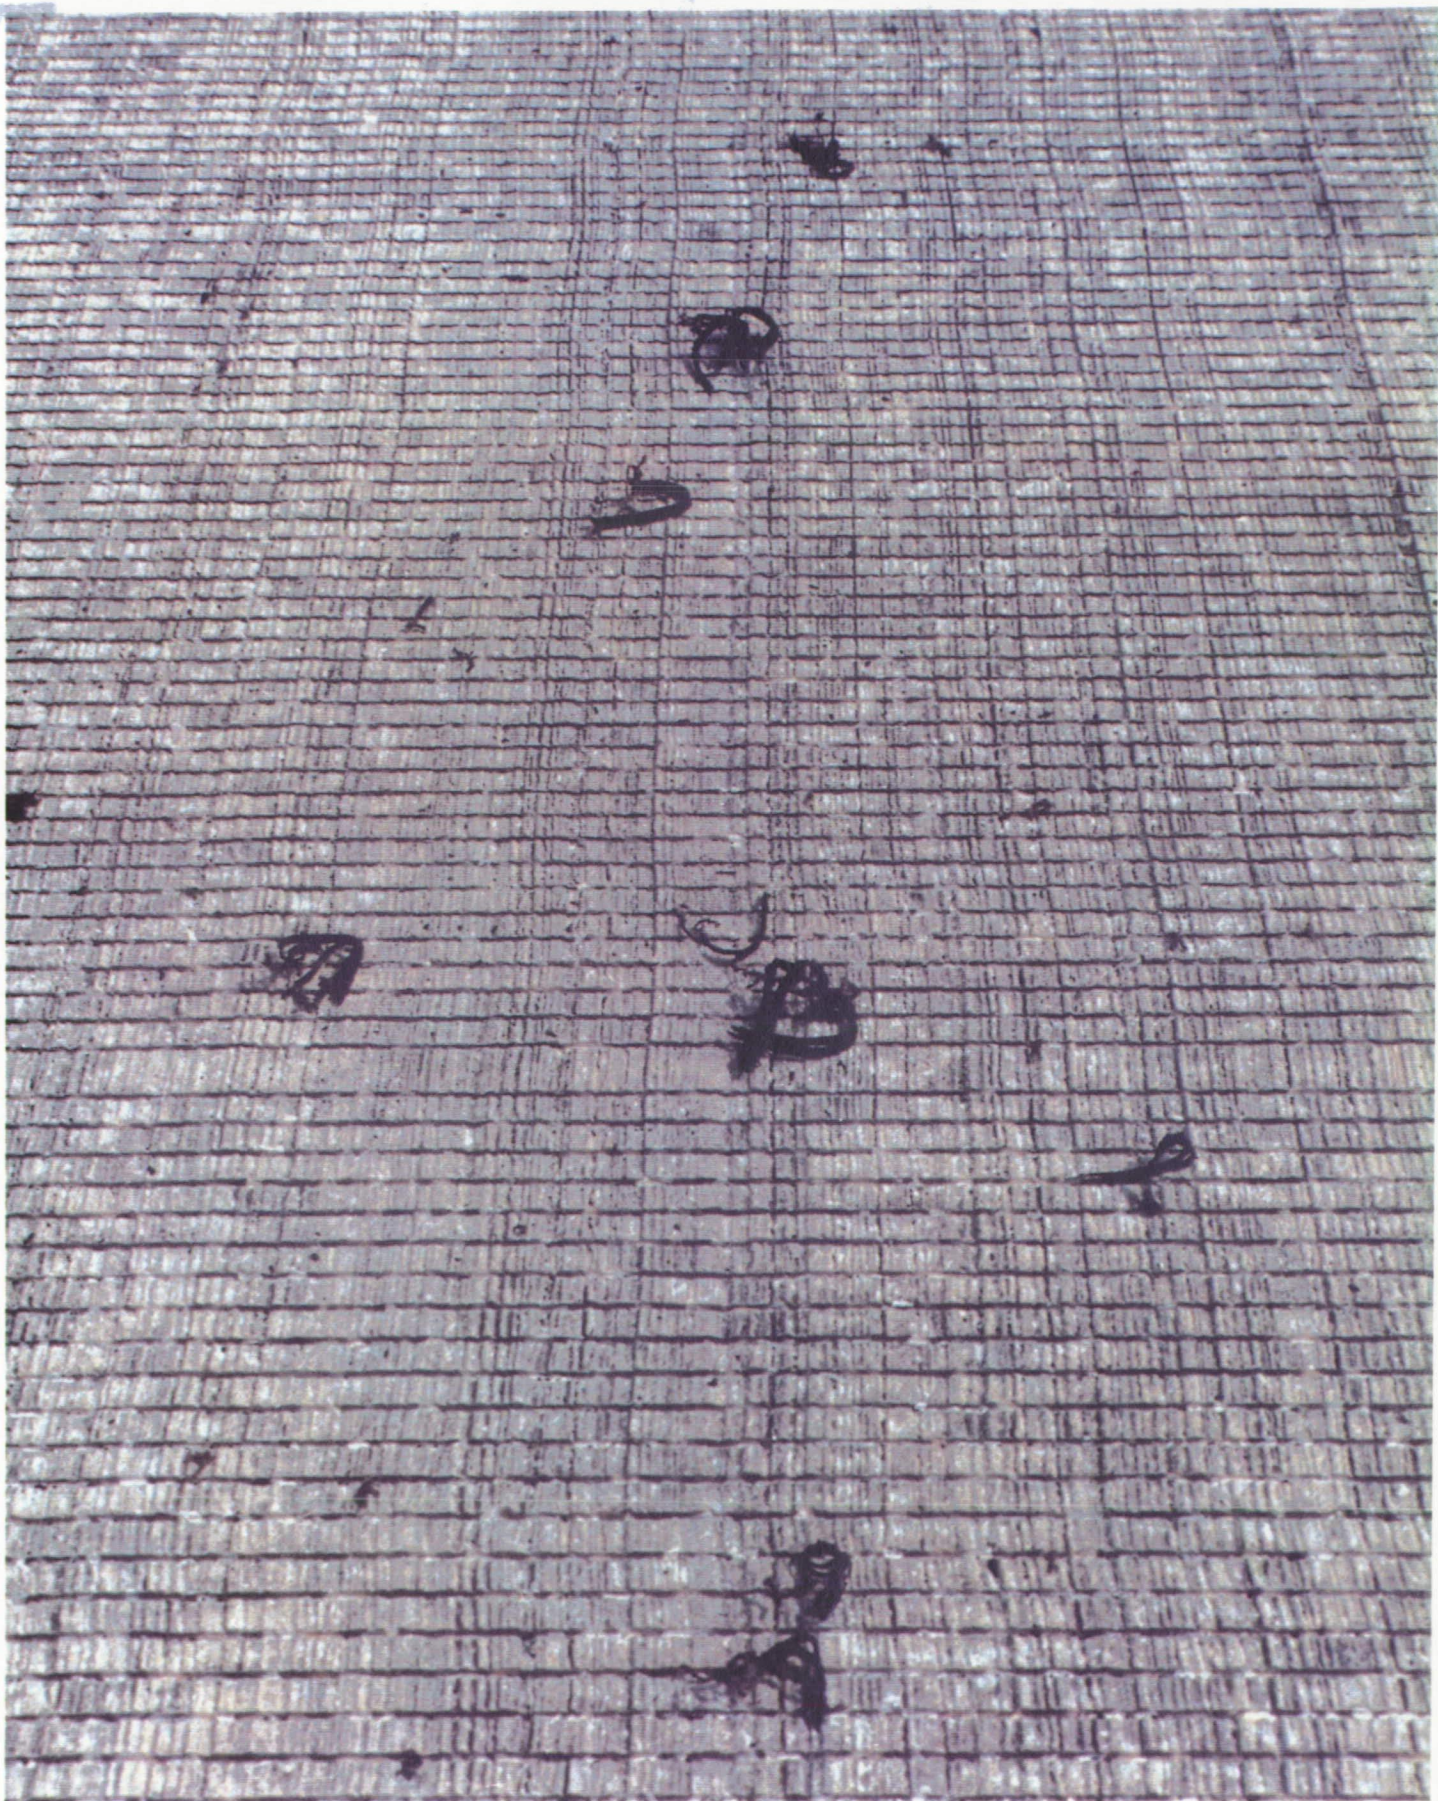
Three plies of material were lost from the RH outboard tire
and 1 ply was lost from the RH inboard tire
